# ECOLOGICAL SURVEY OF WELBOURN BECK REPORT OCTOBER 2025

29/10/2025

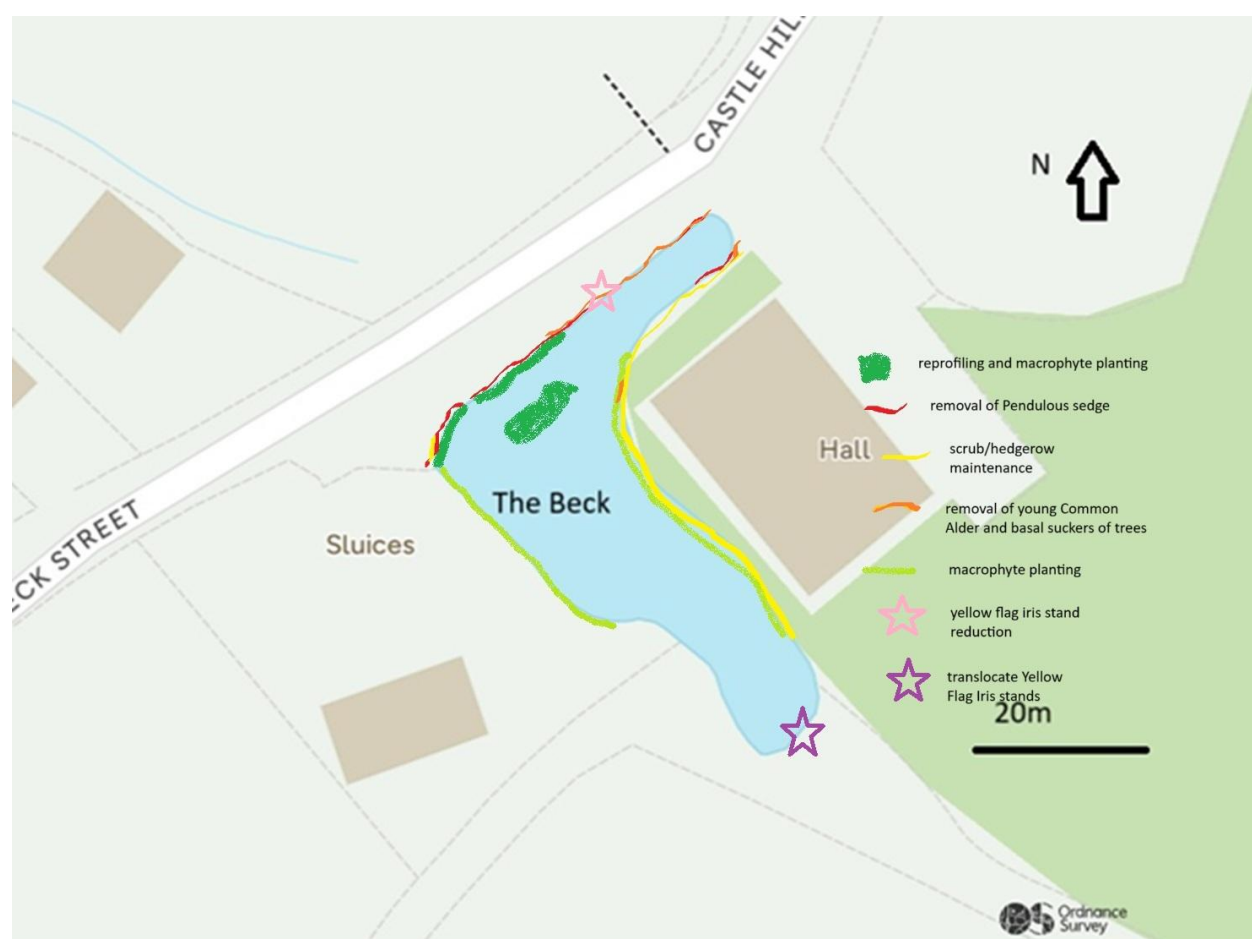
Figure 3 Proposed Vegetation Mitigation Measures

Recommendations for macrophyte planting for the margins and open water are given below in Table 3 and Figure 3 summarises recommendations for vegetation works in the short term (next two to three years). The landowners with the garden on the western bank may be agreeable to some macrophyte planting on their margin.

It is recommended that the Pendulous Sedge tussocks are partially removed from the Beck margins along Beck St to make room for a more varied marginal flora. This is a vigorous species that has out-competed the previous marginal vegetation likely because it is perennial and can withstand the physical effects of duck grazing (see Plate 6 and 2). The margins along the narrow eastern outfall are very shaded and so removal efforts should focus on the better lit south-western half to support the diversification of the margins by planting new species. Some of the tussock near the northeastern outfall should be removed to provide improved access to clear debris from the grill and maintain good outflow.

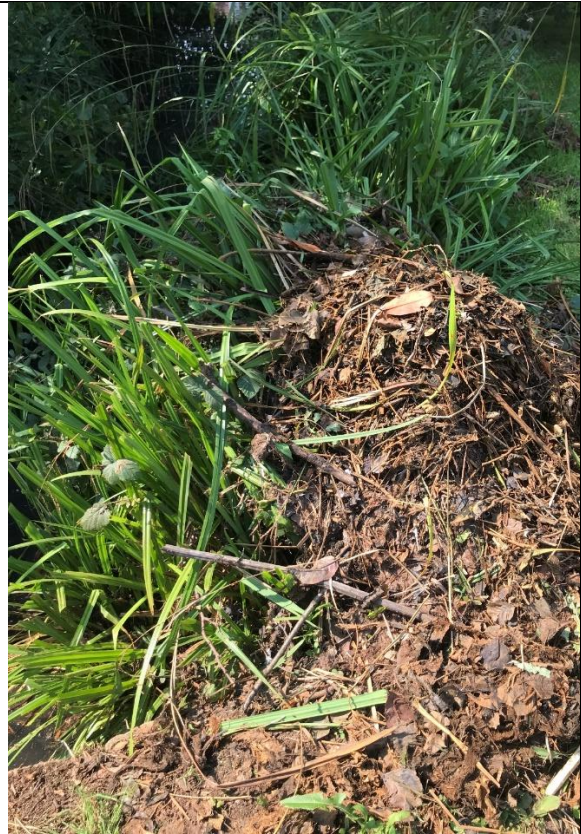
There are two obvious culverted, gridded concrete outflows (see Figure 2) although very little water appeared to be flowing through the grid near T2. There was some flow through the most northerly outflow at the time of the survey which is periodically cleared by private residents (see Plate 1).

1 Arisings from drain outfall clearance

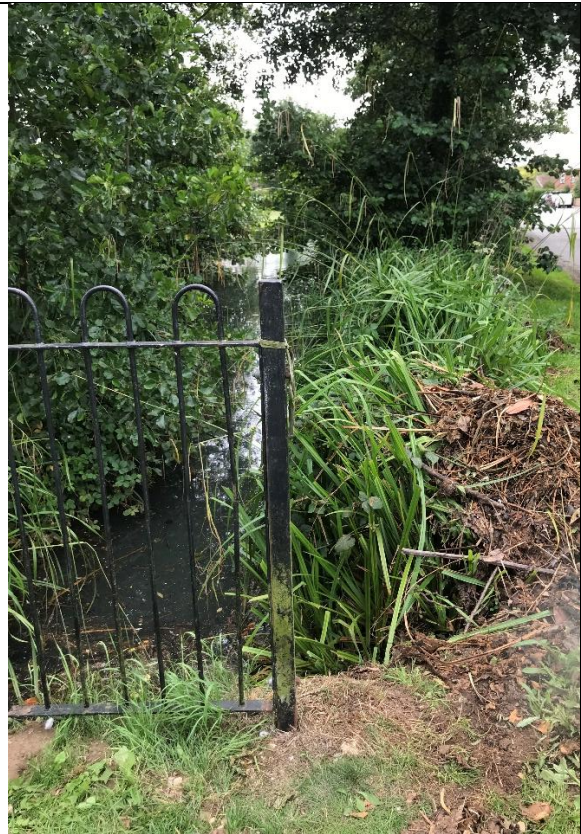
2 Shaded and turbid eastern arm of the Beck showing marginal pendulous Sedge and young Common Alder

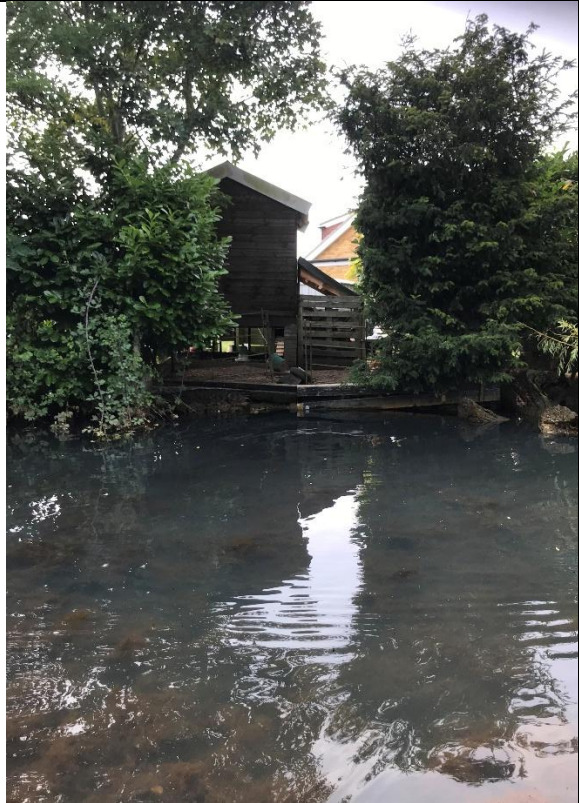
It was found growing on the wetted lower bank by the chicken run where organic rich chicken dung is free to enter the Beck, especially during rain fall events. Invertebrate sample 2 (see Table 1 for results) which comprised solely pollution tolerant midge larvae, also suggests that could be local water quality issues potentially arising from the chicken dung runoff. The midge larvae have high levels of haemoglobin and can survive in low oxygen environments.

4 Bank top chicken run on western bank  
(see T1 on Figure 2 for location)  
Potential rat holes were visible at the water  
line close to the run.

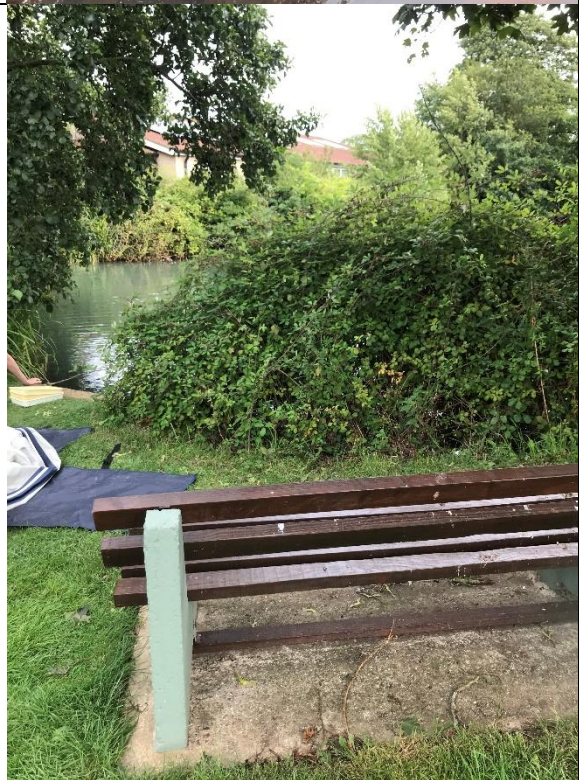
5 View across the pond from the near T2  
the bench on Beck St, showing the  
bramble obscuring the view across the  
Beck.

The gap in the vegetation is due to the  
outfall's presence.

The hedgerow along the edge of the  
eastern bank is visible in the background.

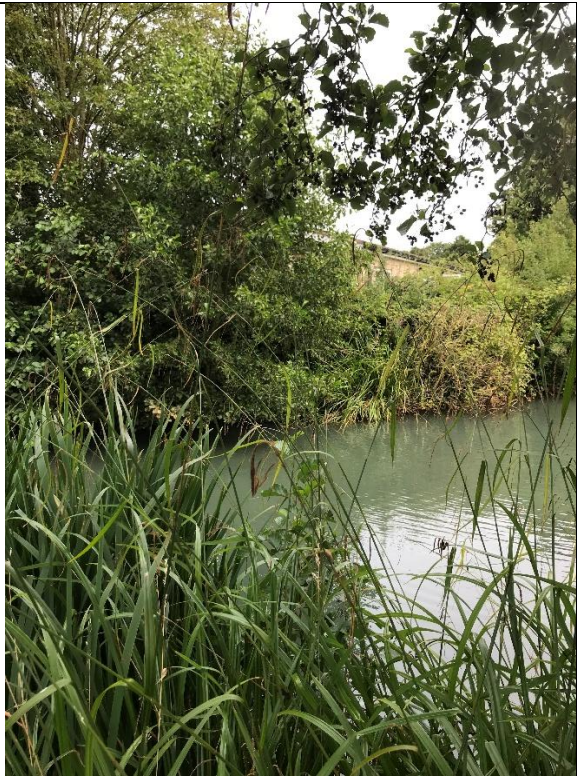
6 Foreground shows Pendulous Sedge which dominates the bank margins. Young Common Alder on the corner of the western edge recommended for removal along with saplings on northwest bank by Beck St.

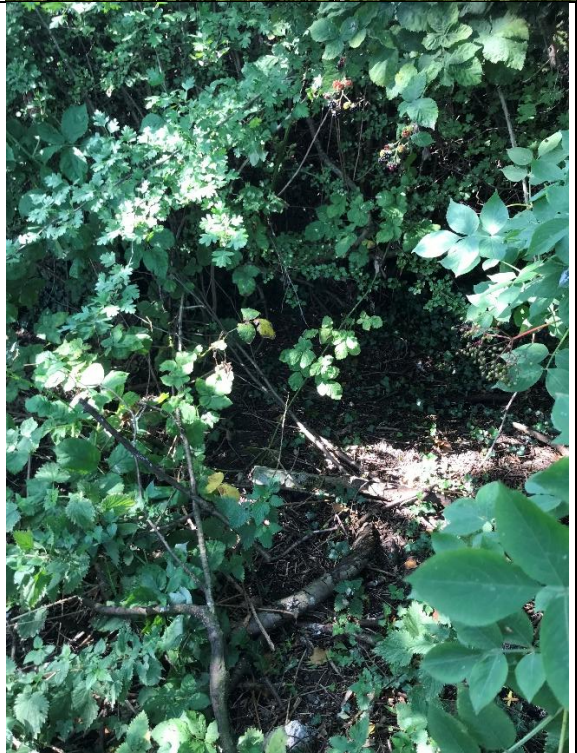
7 Dry inflow from the south

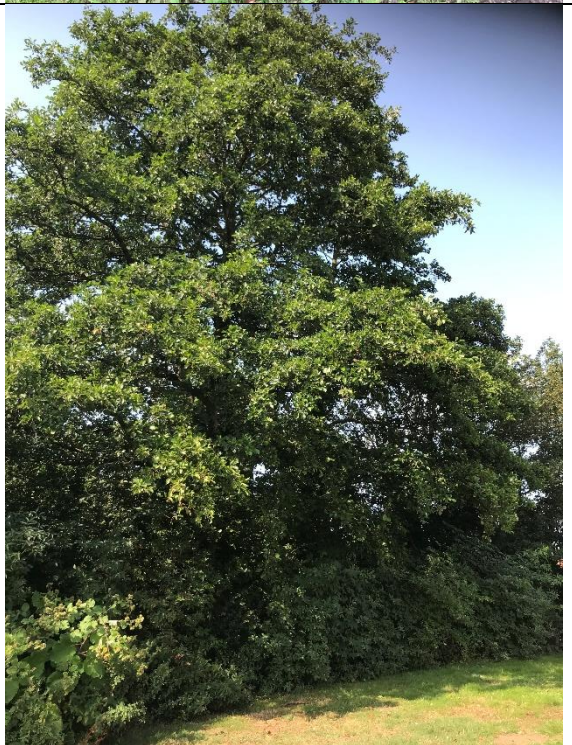
9 Tall Common Alder over hedgerow at the southern end of the Beck

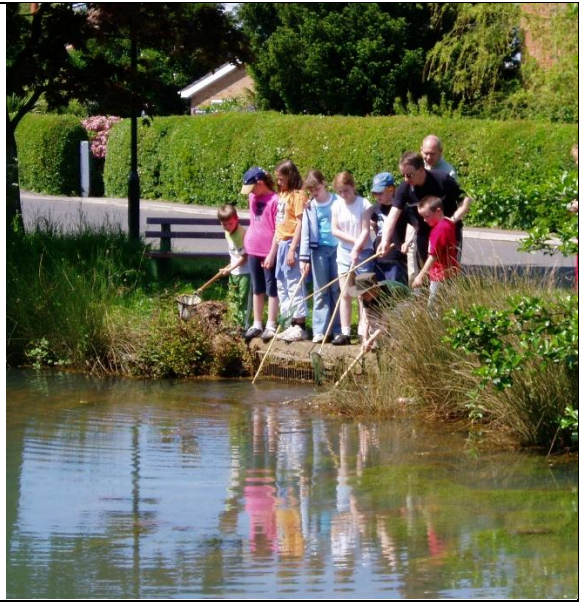
10 May 2004 Wildlife Watch Group members pond dipping at the Beck. Note turbid water and extensive filamentous algal growth. There is also a pond vista from the bench. Soft Rush much evident in the Beck margins (Photograph Source Marianne Overton)
